# ANNUAL REPORT FOR 2008

**Myrick Pond Mitigation Site  
Richmond County  
TIP No. R-2231**

Prepared By:  
Natural Environment Unit & Roadside Environmental Unit  
North Carolina Department of Transportation  
December 2008

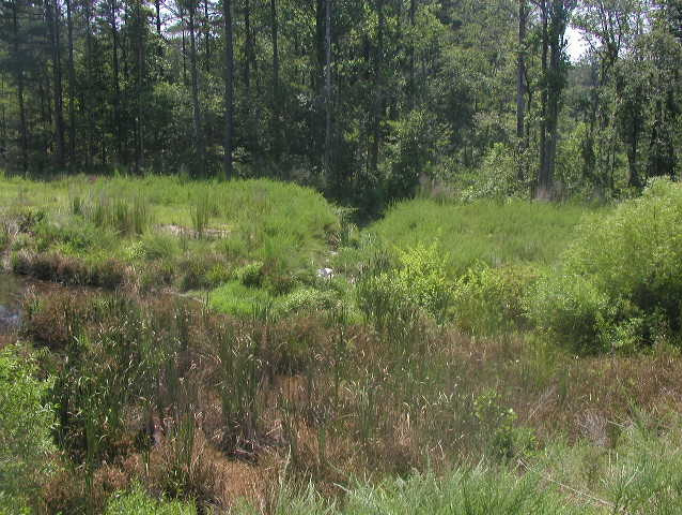
Photo Point #7 (Looking Downstream at the Outlet End of the Box Culvert)
